NATIONAL DAM SAFETY PROGRAM. VALLE LAKE DAM (MO 30438), MISSISS-ETC(U)

VALLE LAKE DAM
JEFFERSON COUNTY, MISSOURI
MO. 30438

**PHASE I INSPECTION REPORT
NATIONAL DAM SAFETY PROGRAM**

PREPARED BY: U. S. ARMY ENGINEER DISTRICT, ST. LOUIS

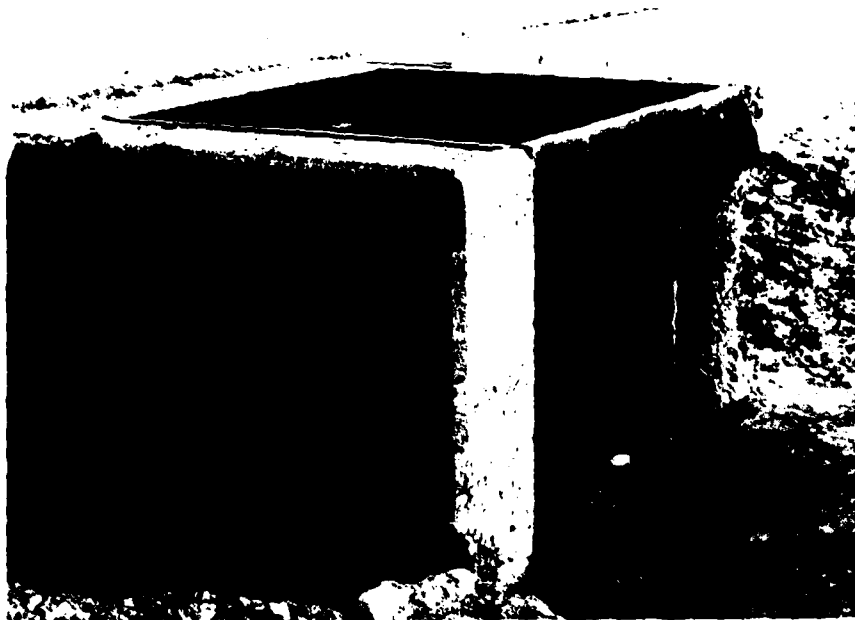
The front edge of the right sidewall has partially disintegrated into the stoplog slot (see Photo 7). No reinforcement was evident. The remaining concrete surfaces appeared stable with minor weathering observed. A small amount of debris was seen in the bottom of the drop inlet; however, the spillway was operating on the day of the inspection. It appears that some repair work was done

1. The disintegration of the principal spillway right sidewall does not presently affect the safety of the dam. Further deterioration will preclude the use of the stoplog slot and the reservoir regulation that the drop inlet provides will be lost. The complete failure of the wall could impair the functioning of the spillway and thus imperil the safety of the dam.

The structural stability of the principal spillway appears to be questionable due to the disintegration of the drop inlet wall. However, this damage does not constitute an unsafe condition at this time. The emergency spillway appeared to be structurally stable with the exception of the voids on the back slope caused by erosion. The principal spillway was partially obstructed by debris on the day of the inspection, however, it was operating. The emergency spillway was unobstructed and appeared to be able to function properly.

Photo 7 - Close-up view of the principal spillway drop inlet showing the concrete deterioration of the stoplog slot.

1. Further investigation of the three areas of seepage and possible seepage observed along the downstream slope should be undertaken to determine the seriousness of the condition. The investigation should be carried out under the direction of a qualified professional engineer and repairs made as required.
2. The damage to the principal spillway drop inlet sidewall should be repaired.

3. The debris should be removed from the drop inlet structure and measures taken to prevent debris from entering the structure in the future.
4. The undermining of the concrete principal spillway outlet pad should be repaired and the area protected from future damage.
